CALSPAN ON-SITE AIR BAG DEPLOYMENT INVESTIGATION

CALSPAN CASE NO. 92-4

VEHICLE - 1986 FORD TEMPO GL

ACCIDENT DATE - ██████████ 1991

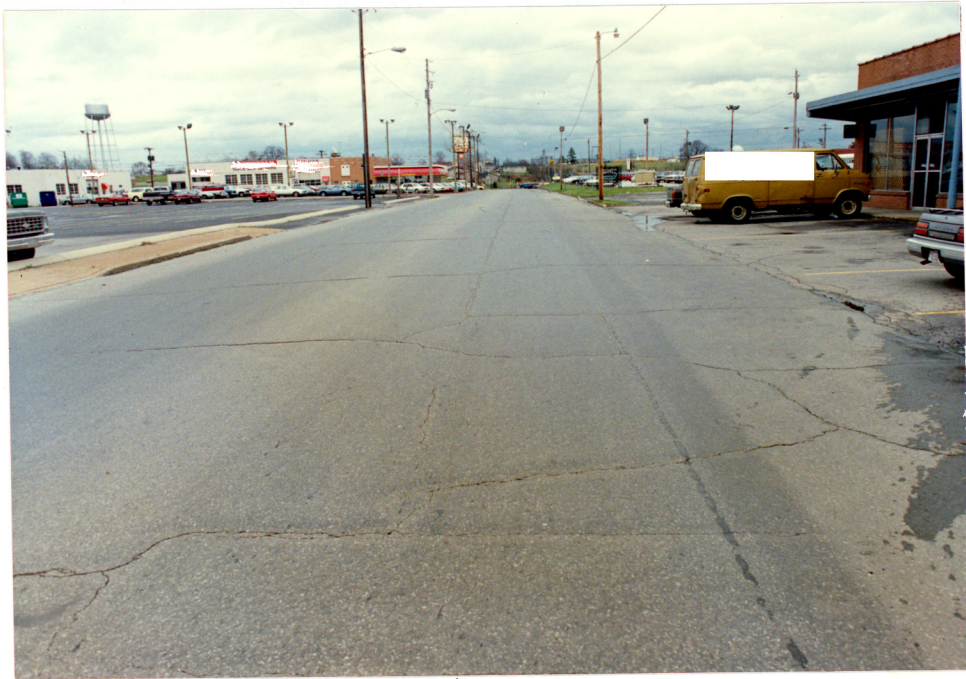
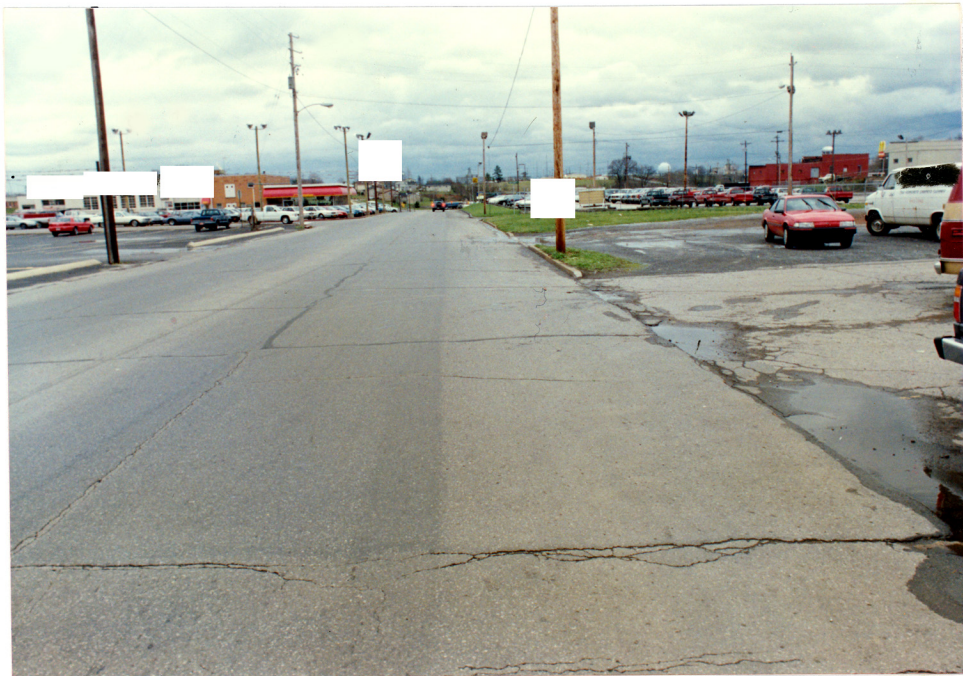
Pre-Crash Trajectory Of The 1986 Ford Tempo.

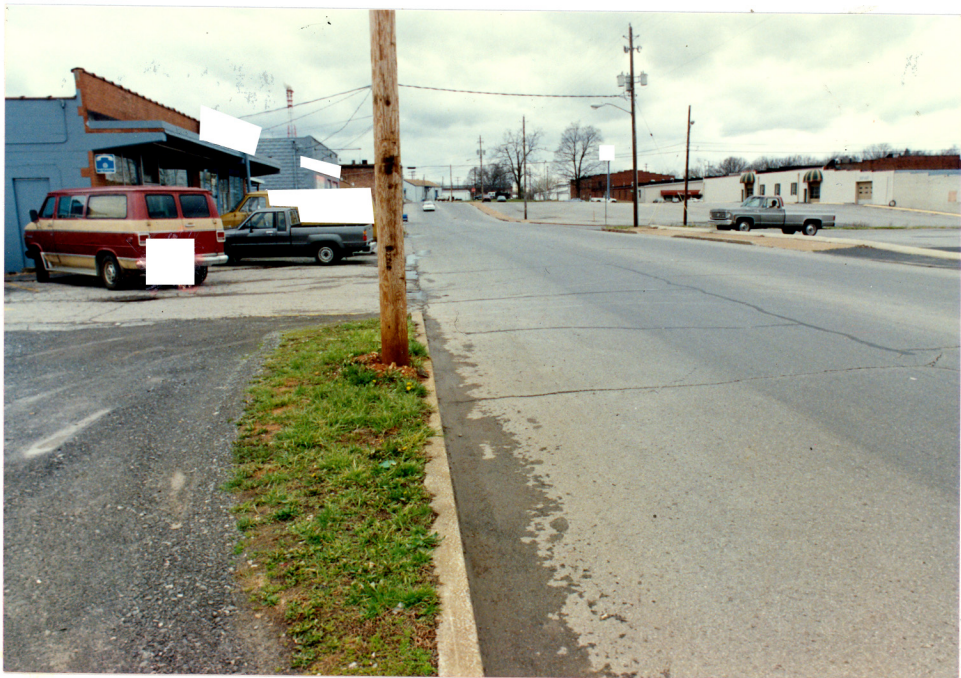
Lookback View Of The Vehicle's Trajectory.

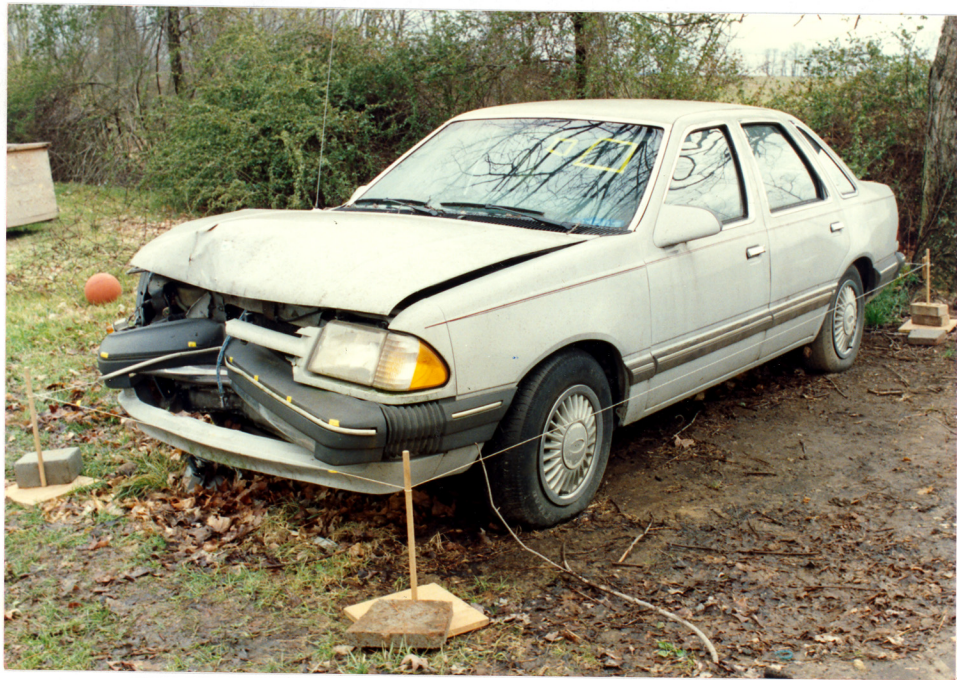
The Ford Tempo sustained moderate frontal damage as a result of its impact sequence with the wooden utility pole. Maximum crush was 14.75" located on the bumper face 13.1" right of center. Direct contact damage began 5.6" right of center and extended 8.0" to the right. The impact deformed the entire frontal width of the vehicle which resulted in a combined induced and direct contact damage length of 48". Crush values at bumper level were as follows:  $C_1=0"$ ,  $C_2=2.0"$ ,  $C_3=6.0"$ ,  $C_4=10.375"$ ,  $C_5=12.0"$ ,  $C_6=5.75"$ .

Left Front Three-Quarter View.

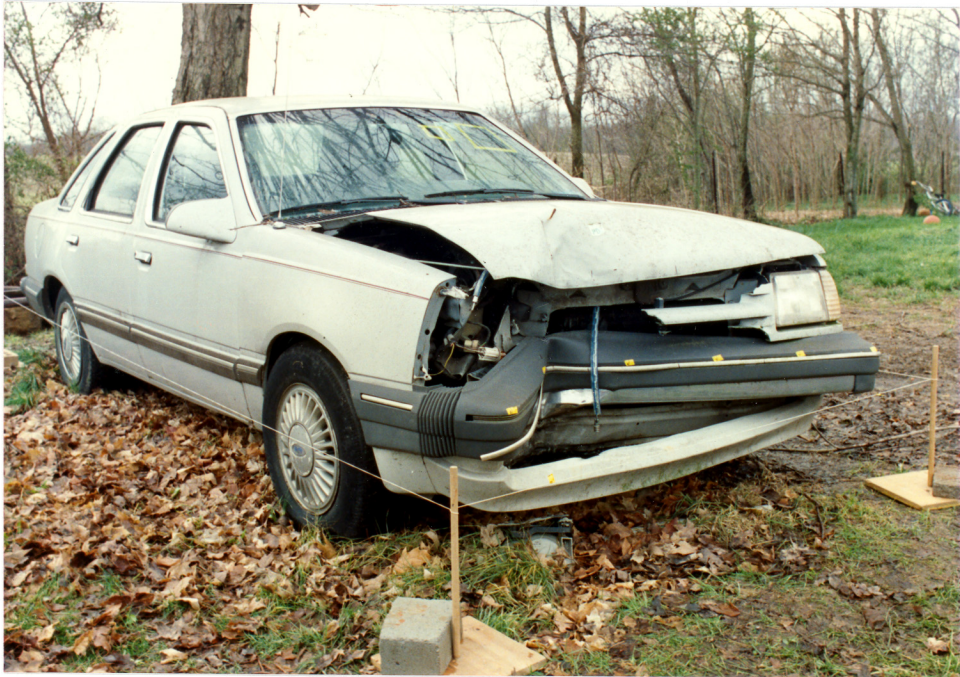
Components damaged by the narrow frontal impact sequence included the front bumper, grille, right headlamp assembly, hood, radiator and radiator support panel, and the air conditioning condensor. The impact crushed the bumper to a V-configuration which displaced the front frame rails laterally inward. As a result of the rail displacement, the right front air bag crash sensor was rotated both inward and upward. The left crush sensor was rotated slightly clockwise.

Right Front Three-Quarter View.

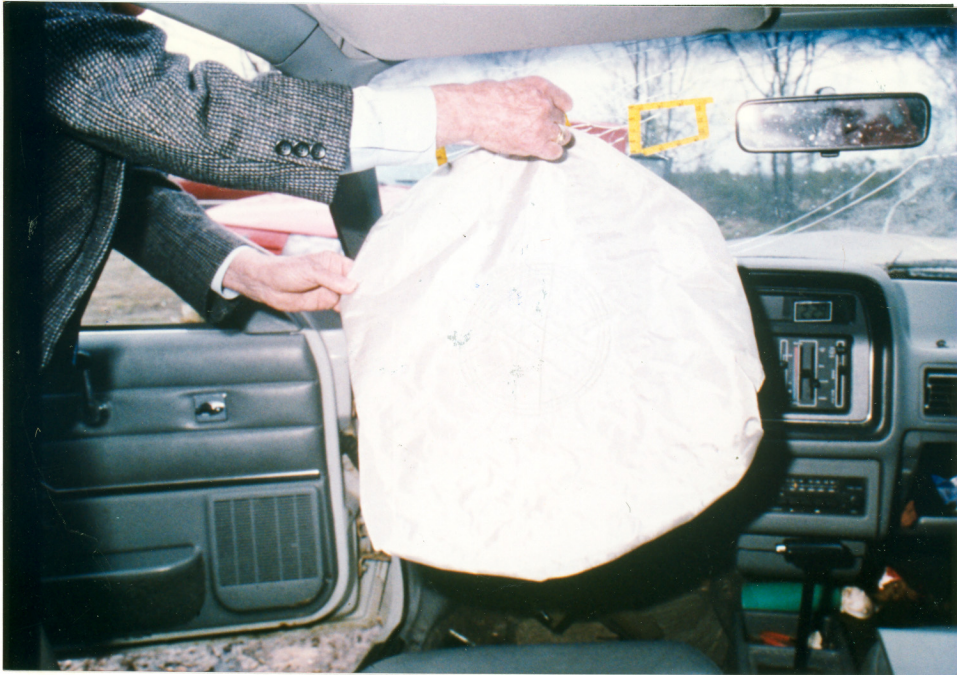
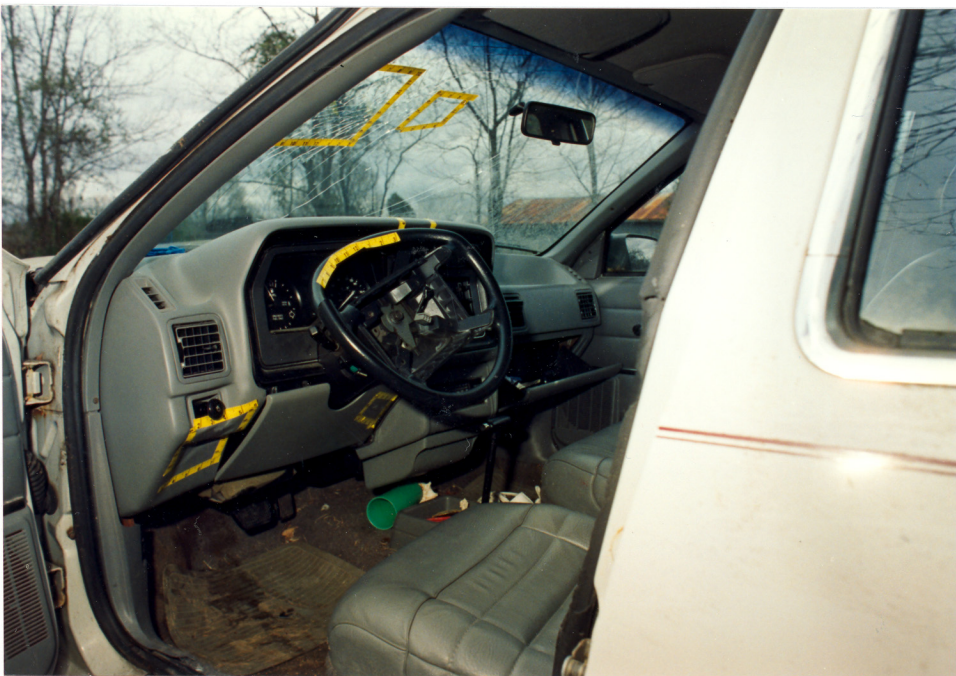
Overall Interior Views From The Left Door Area.

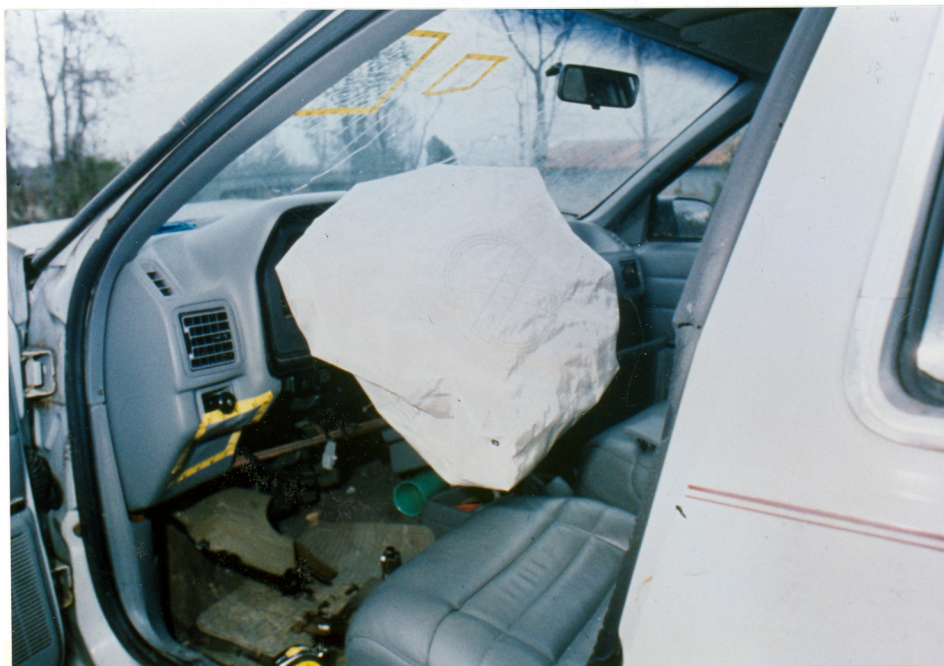
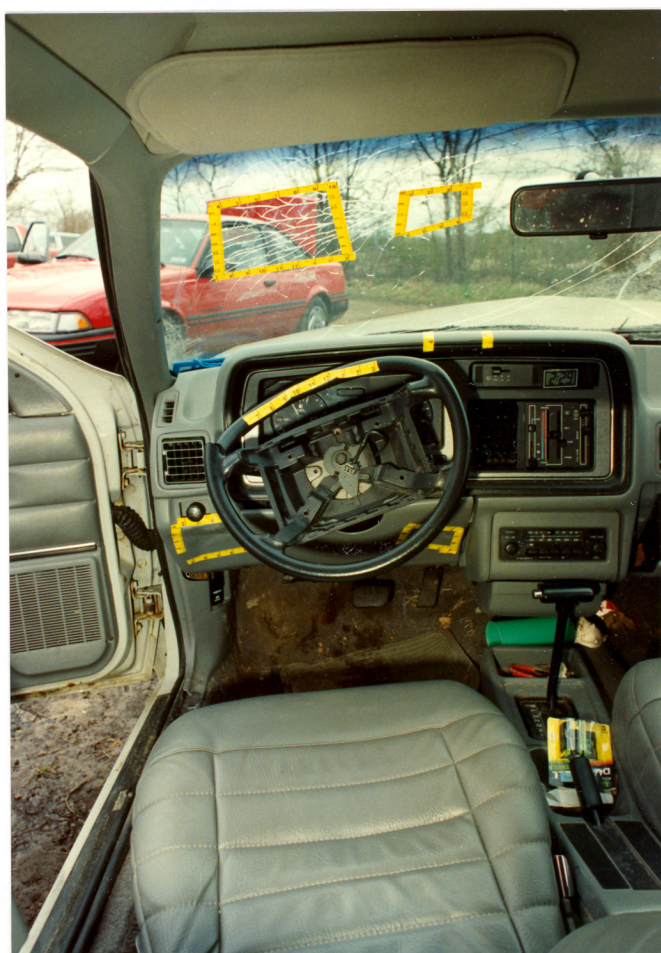
Due to the driver's forward position at impact, her upper abdominal area loaded the lower edge of the steering wheel rim (wheel was rotated 180° at impact) and deformed the rim 3.25" forward. Her contact with the soft edged steering wheel rim resulted in ecchymosis of the upper abdominal area and a ruptured spleen. Her torso contacted the deployed driver's air bag which resulted in bilateral breast contusions. As a result of her loading force against the steering wheel rim and the deployed air bag, the energy absorbing steering column compressed 1.1" (shear capsule compression).

The driver's forehead area pitched over the top of the air bag and impacted the windshield 6.5-9" left of center. The contact cracked the laminated glass and deposited tissue transfers on the glass 6.5-9" above the upper panel. No injury resulted from her contact with the windshield. Vertically oriented fabric transfers were noted to the windshield 13-19" left of center which resulted from air bag contact with the glass.

Driver's Trajectory And Interior Contact Points.

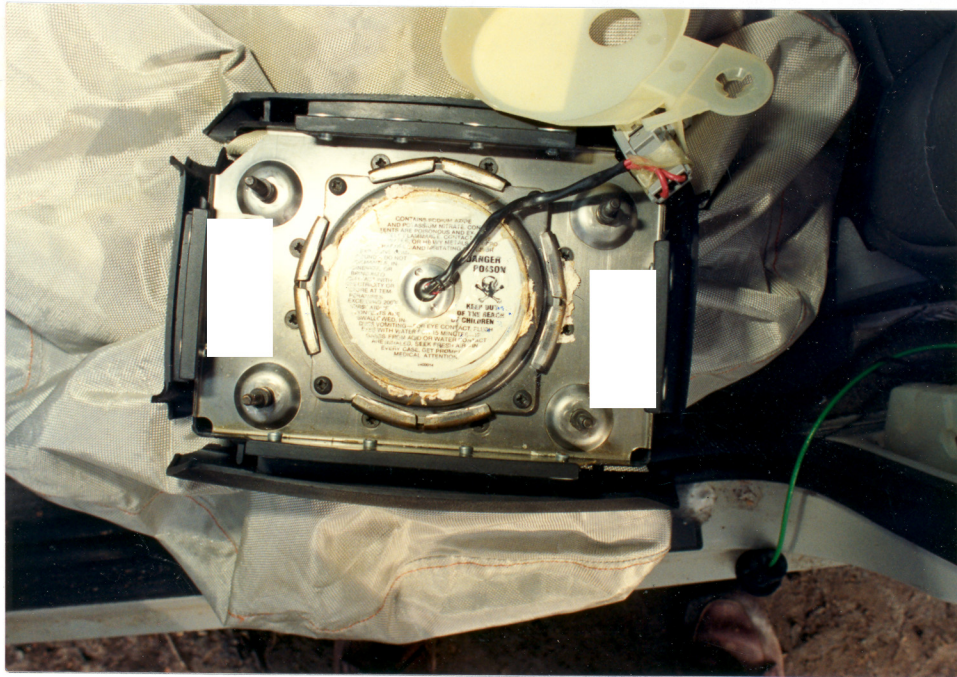
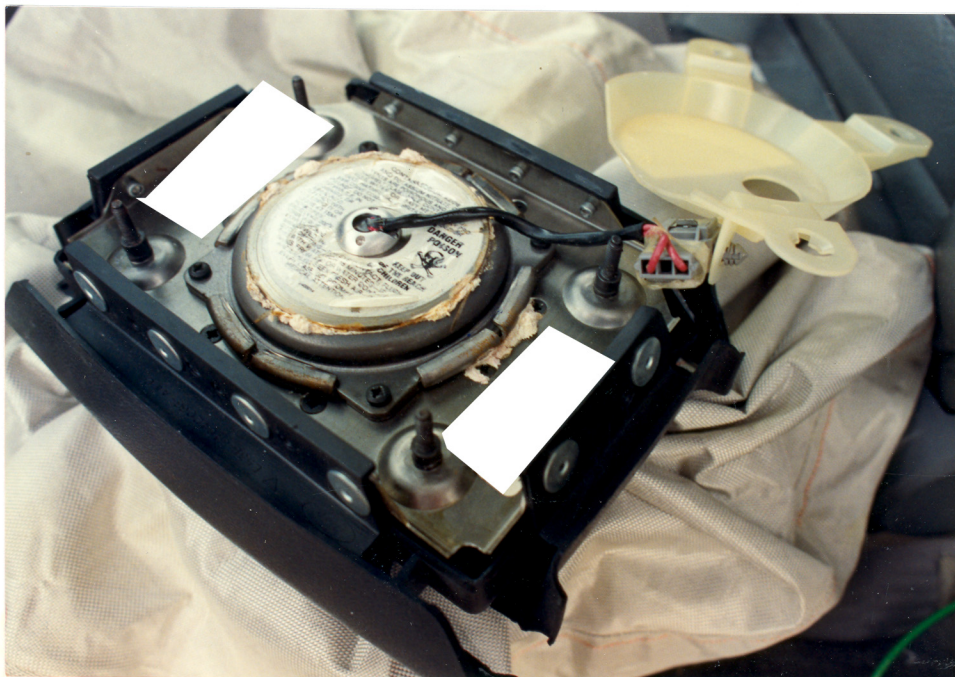
Backside Views Of The Air Bag Inflator Housing.

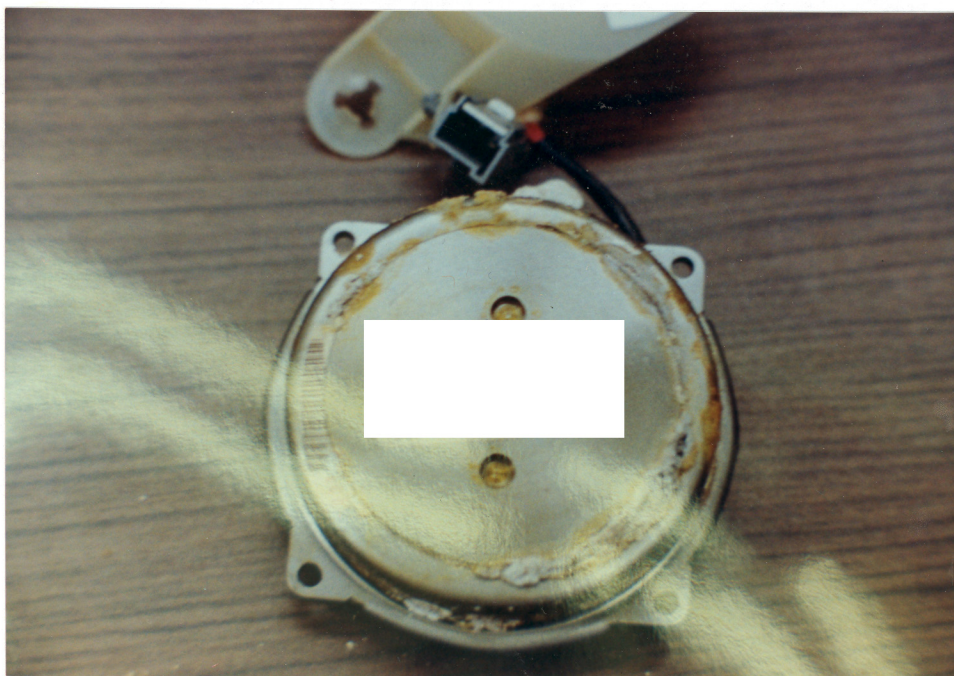
The air bag module assembly had been removed from the vehicle prior to our on-site inspection. The module was properly removed from the steering wheel without damage. The air bag was intact with no cuts or tears of the bag fabric. There was no evidence of driver contact on the bag (i.e., makeup transfers, etc.). Several faint stains which appeared to be blood were observed on the face of the bag.

The air bag was of normal construction and measured approximately 23" in diameter in its deflated state. The bag was a tethered design and there was no damage to the internal tether straps or to the center reinforcement area of the bag. The air bag was vented by two ports located on the back side of the bag at the 10 and 4 o'clock positions. The air bag and module assembly were identified by the following numbers:

Air Bag Side Of The Inflation Module.

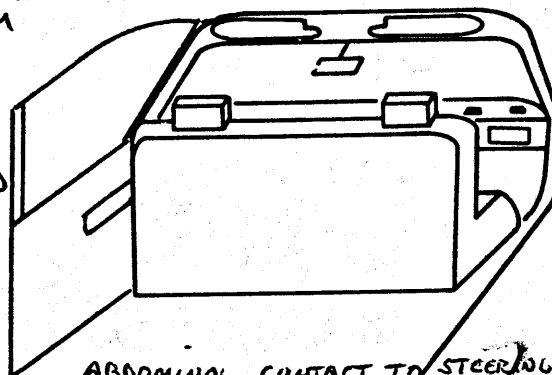
NO LOADING EVIDENCE  
ON BELT SYSTEMDRIVER'S SEAT ROTATED  
~15° CCW BY CRASH  
FORCES, ADJUSTED  
3" REARWARD OF  
FULL FORWARD  
POSITION

ABDOMINAL CONTACT TO STEERING WHEEL  
RIM, WHEEL PROBABLY ROTATED 180° AT  
TIME OF CONTACT  
UPPER STEERING WHEEL DISPLACED

3.25" FORWARD, BENDING BEGINS 2" ABOVE  
LOWER (L) SPOKE, CONTINUES CW TO (R)  
UPPER SPOKE

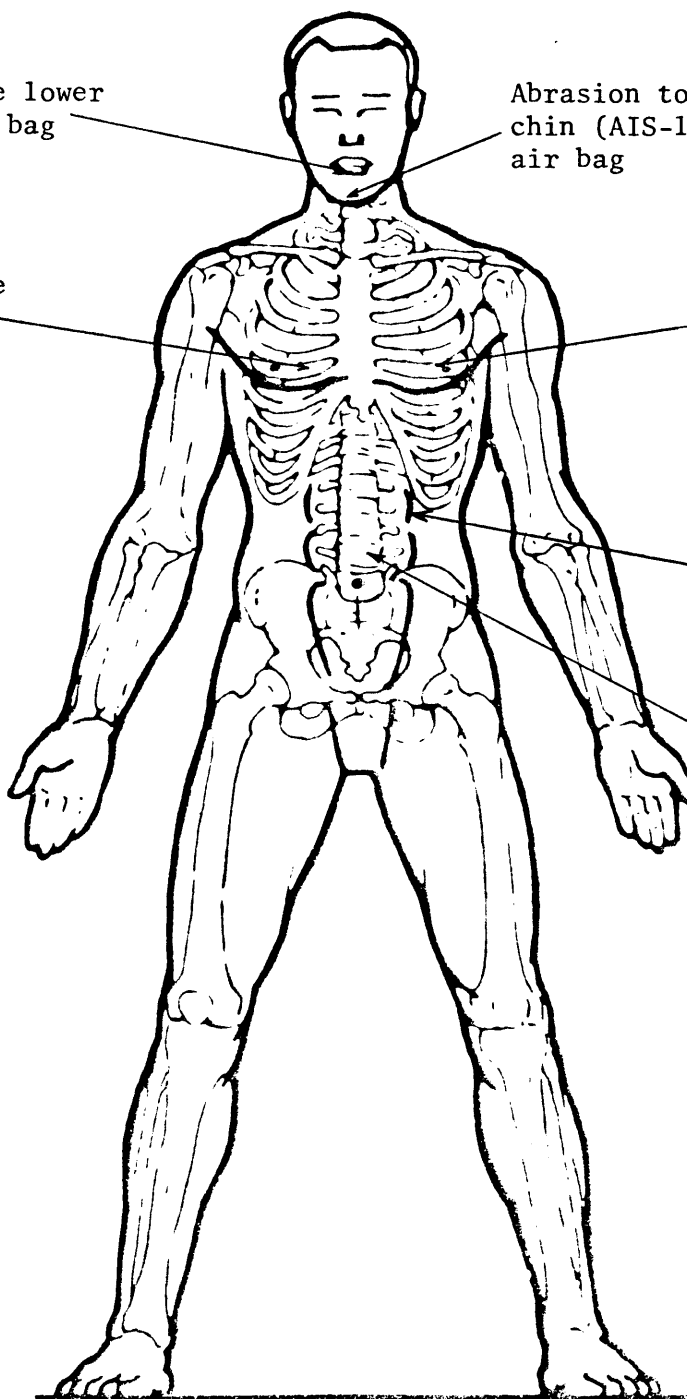
Ruptured spleen with  
extensive hemorrhage  
(AIS-3), steering wheel  
rim

Ecchymosis of the upper  
abdomen (AIS-1), steering  
wheel rim
